Equalize pressure to ensure reliable LED-based outdoor luminaires

Dealing with pressure differential is a hidden design challenge for robust LED luminaires, reports **GARY CHAN**, although preventing moisture ingress and venting products properly can deliver long, reliable lifetimes.

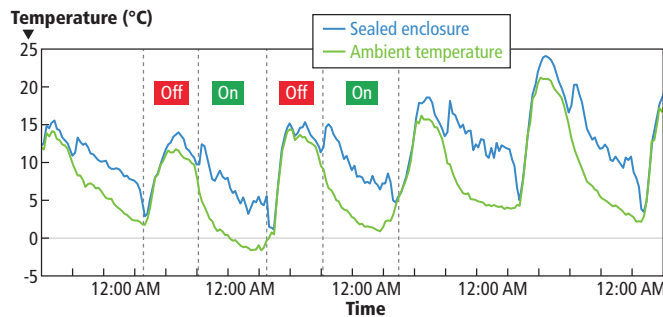
FIG. 1. Temperature fluctuations inside a sealed luminaire.

Fig. 1 shows how temperature can fluctuate inside and outside the luminaire mapped relative to power on and off cycles for the luminaire. Temperature rises inside the luminaire when it is powered on. As a luminaire turns on and off, the changes in the temperatures result in sudden pressure differentials (Fig. 2). The housing tries to relieve the pressure by drawing air inside, which increases stress on the seals (a process sometimes referred to as pressure equalization).

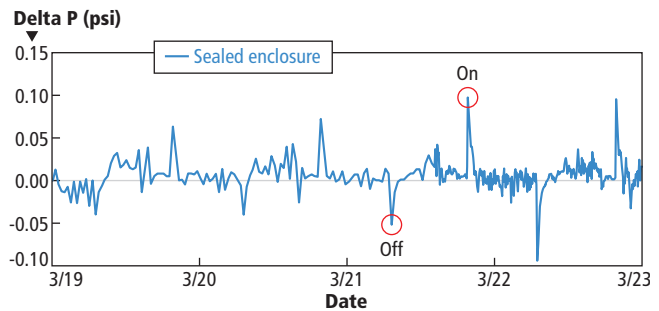
FIG. 2. Pressure differentials result as a luminaire turns on and off. The inability of the luminaire to hold pressure indicates the existence of leak path.

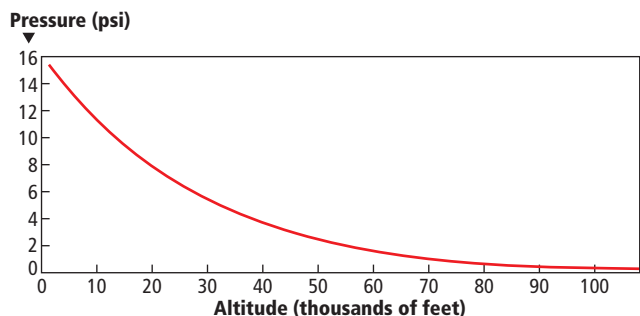
FIG. 3. Pressure changes are experienced during altitude changes during shipment.

cause of pressure buildup. Although luminaires are usually stationary once installed, altitude issues occur as the luminaires are shipped from the manufacturing facility to the installation site. Because most shipping containers on cargo planes are not pressurized, luminaires can be exposed to significant pressure differentials during take-off and landing, decreasing from almost 15 psi (1034 mbar) when on the ground to about 3 psi (137.9 mbar) at an altitude of 40,000 feet (Fig. 3).

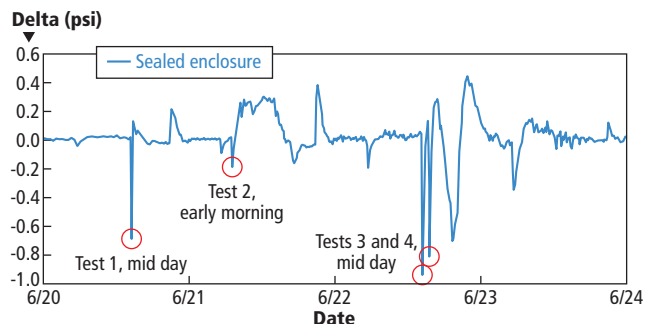
FIG. 4. Pressure differentials caused by tap-water spray using an IPX5 nozzle.

Thermal shock is a third cause of pressure differentials and results from the luminaire being exposed to rain, snow, or washing cycles. Fig. 4 shows the impact on a luminaire’s internal pressure from a water spray using an IEC

60529 Standard IPX5 nozzle at a distance of approximately 3m for three minutes, with a tap water flow of 21 lt/min. Rapid recovery of pressure indicates the failure of the gasket to hold the vacuum, drawing in water along with air at the leak path(s).

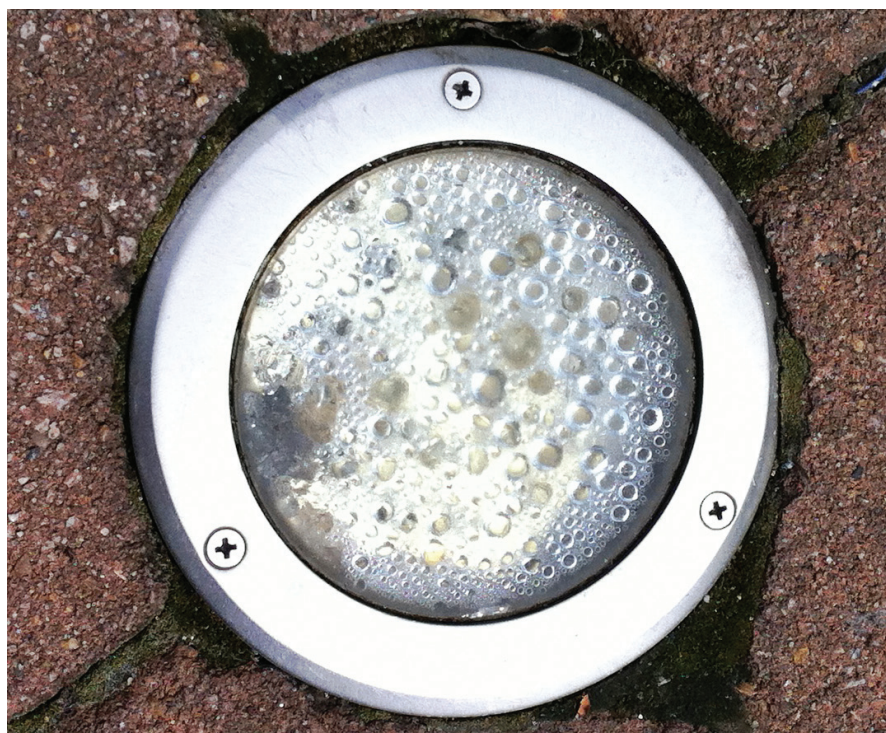
FIG. 5. Condensation inside an LED luminaire limits performance.

In addition to the potential damage to electronics if water and contaminants enter the luminaire, moisture vapor from the water can cause condensation on lenses and reflectors, decreasing light efficiency and the aesthetic quality of the luminaire (Fig. 5).

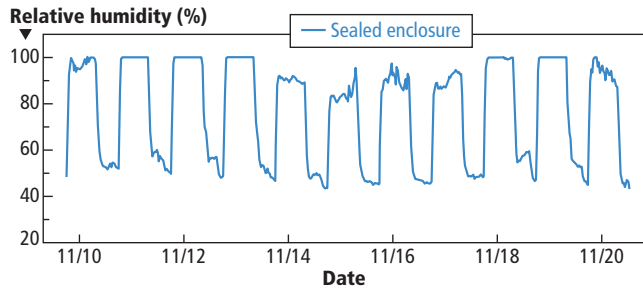
FIG. 6. Condensation events occur inside a luminaire

occurring on the lenses and reflectors. When the relative humidity inside the luminaire reaches 100%, condensation occurs. Once this happens, the condensation will remain unless there is a path for the moisture vapor to escape. Because sealed enclosures do not provide this path, condensation will remain on the lenses and reflectors for extended periods (Fig. 6).

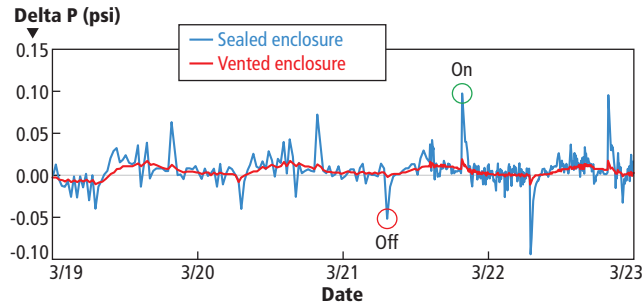
FIG. 8. The impact of pressure differs on vented and sealed housings.

Depending on the quality of the seal, negative 34 mbar (approximately 0.5 psi) is commonly accepted as the point at which a vacuum can cause a leak in a sealed enclosure. Although the on/off cycle of a luminaire causes temperatures to rise and fall in both a vented and a sealed enclosure, the amount of pressure placed on the seals and joints is significantly different (Fig. 8). The testing indicated that pressure in the sealed luminaire spiked as much as 0.09 psi when the light was turned on and dipped approximately -0.1 psi when turned off. However, the vented luminaire showed a change of only ± 0.01 psi.

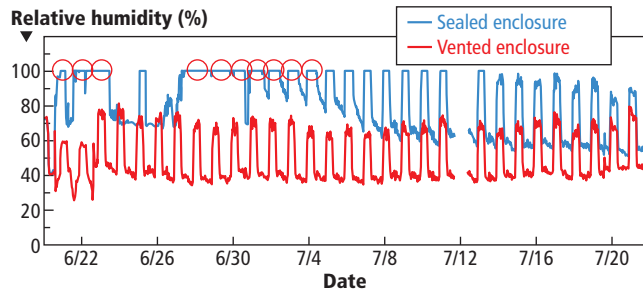
FIG. 9. Extended periods of condensation in a sealed luminaire.

Comparing the relative humidity inside the sealed and vented luminaires after an IPX5 water ingress test demonstrates the significance of pressure differentials. Following the water spray test performed by Gore, the relative humidity in a sealed luminaire remained significantly higher than that in an identical luminaire that was vented (Fig. 9).

Over the course of 10 days, the relative humidity of the sealed luminaire almost always remained at 100%, which indicated the existence of condensation inside the luminaire caused by water entering during the test. Although the relative humidity in the vented luminaire rose after the shock test, it decreased as the moisture vapor escaped from the enclosure, and there was no evidence of condensation.

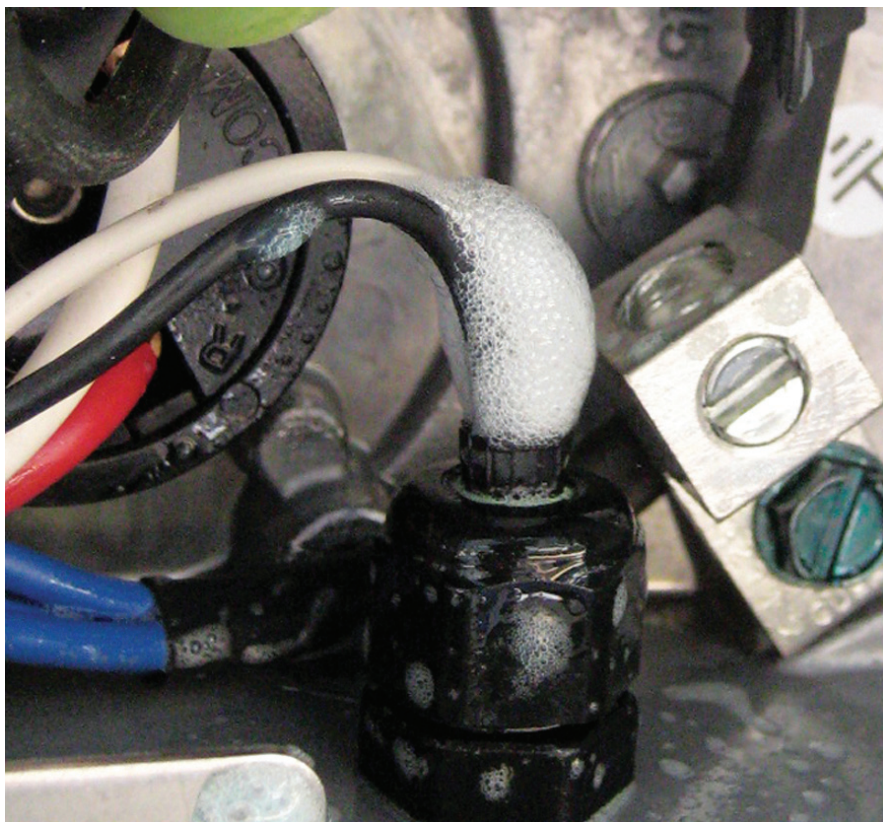
FIG. 7. A leak path can exist in a sealed luminaire.
